United States
Circuit Court of Appeals
For the Ninth Circuit.

UNITED STATES OF AMERICA,
Appellant,

J. LESLIE MORRIS COMPANY, INC., a cor-
poration,
Appellee.

Transcript of Record
(Plaintiff's Exhibits 1 to 32)

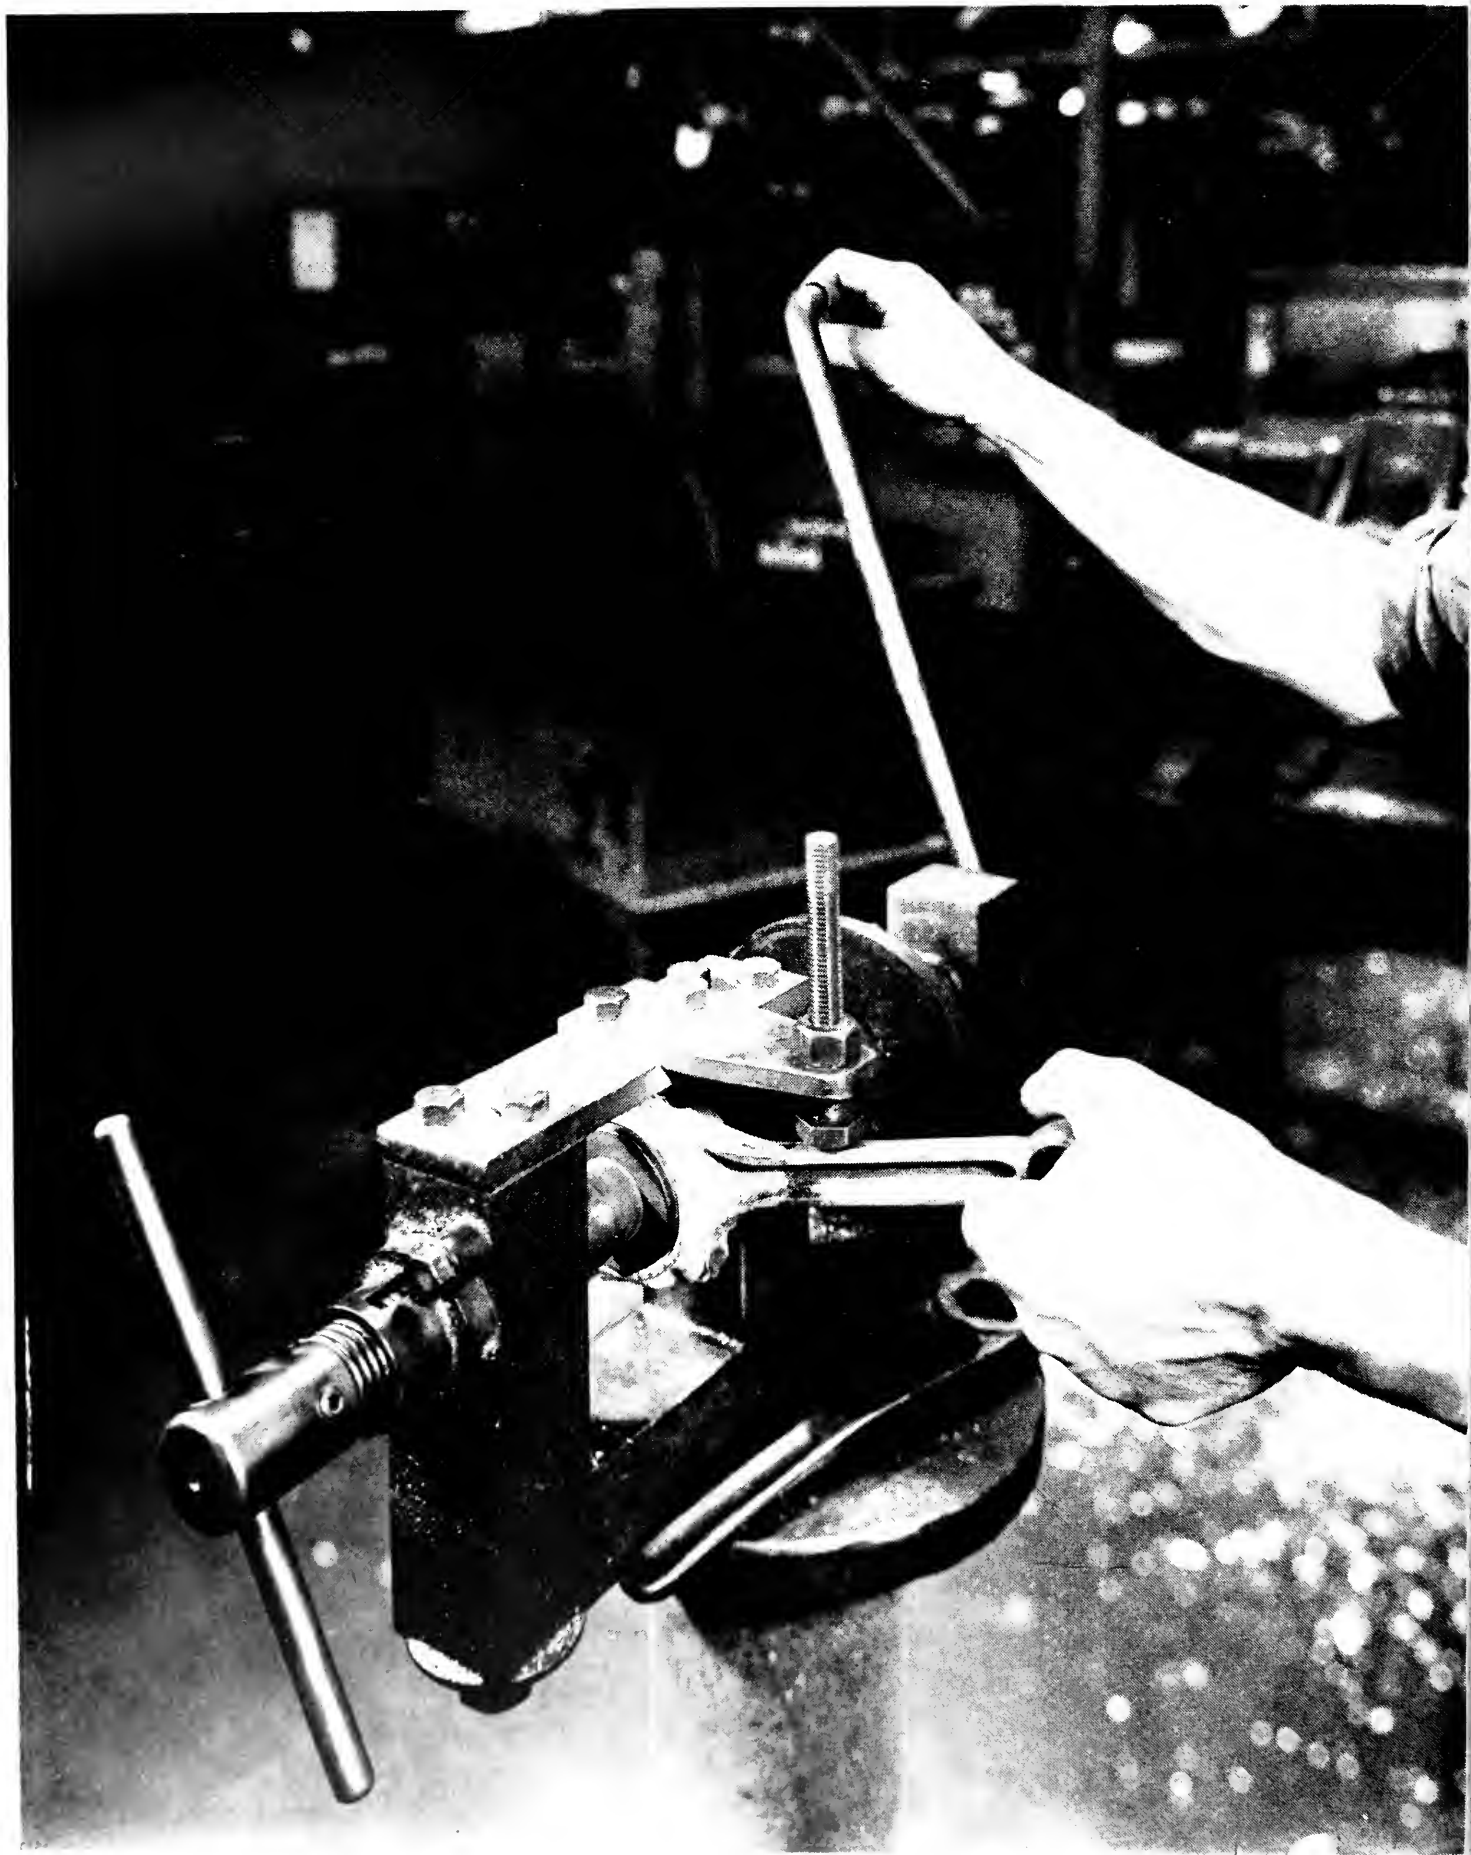
PLAINTIFF'S EXHIBIT No. 28

All Model A Ford and six-cylinder Chevrolet rebabbitted connecting rods require an oil groove on the face of the bearing which is cut in the shape of a figure 8 by hand operated oil groover as shown in the above picture.

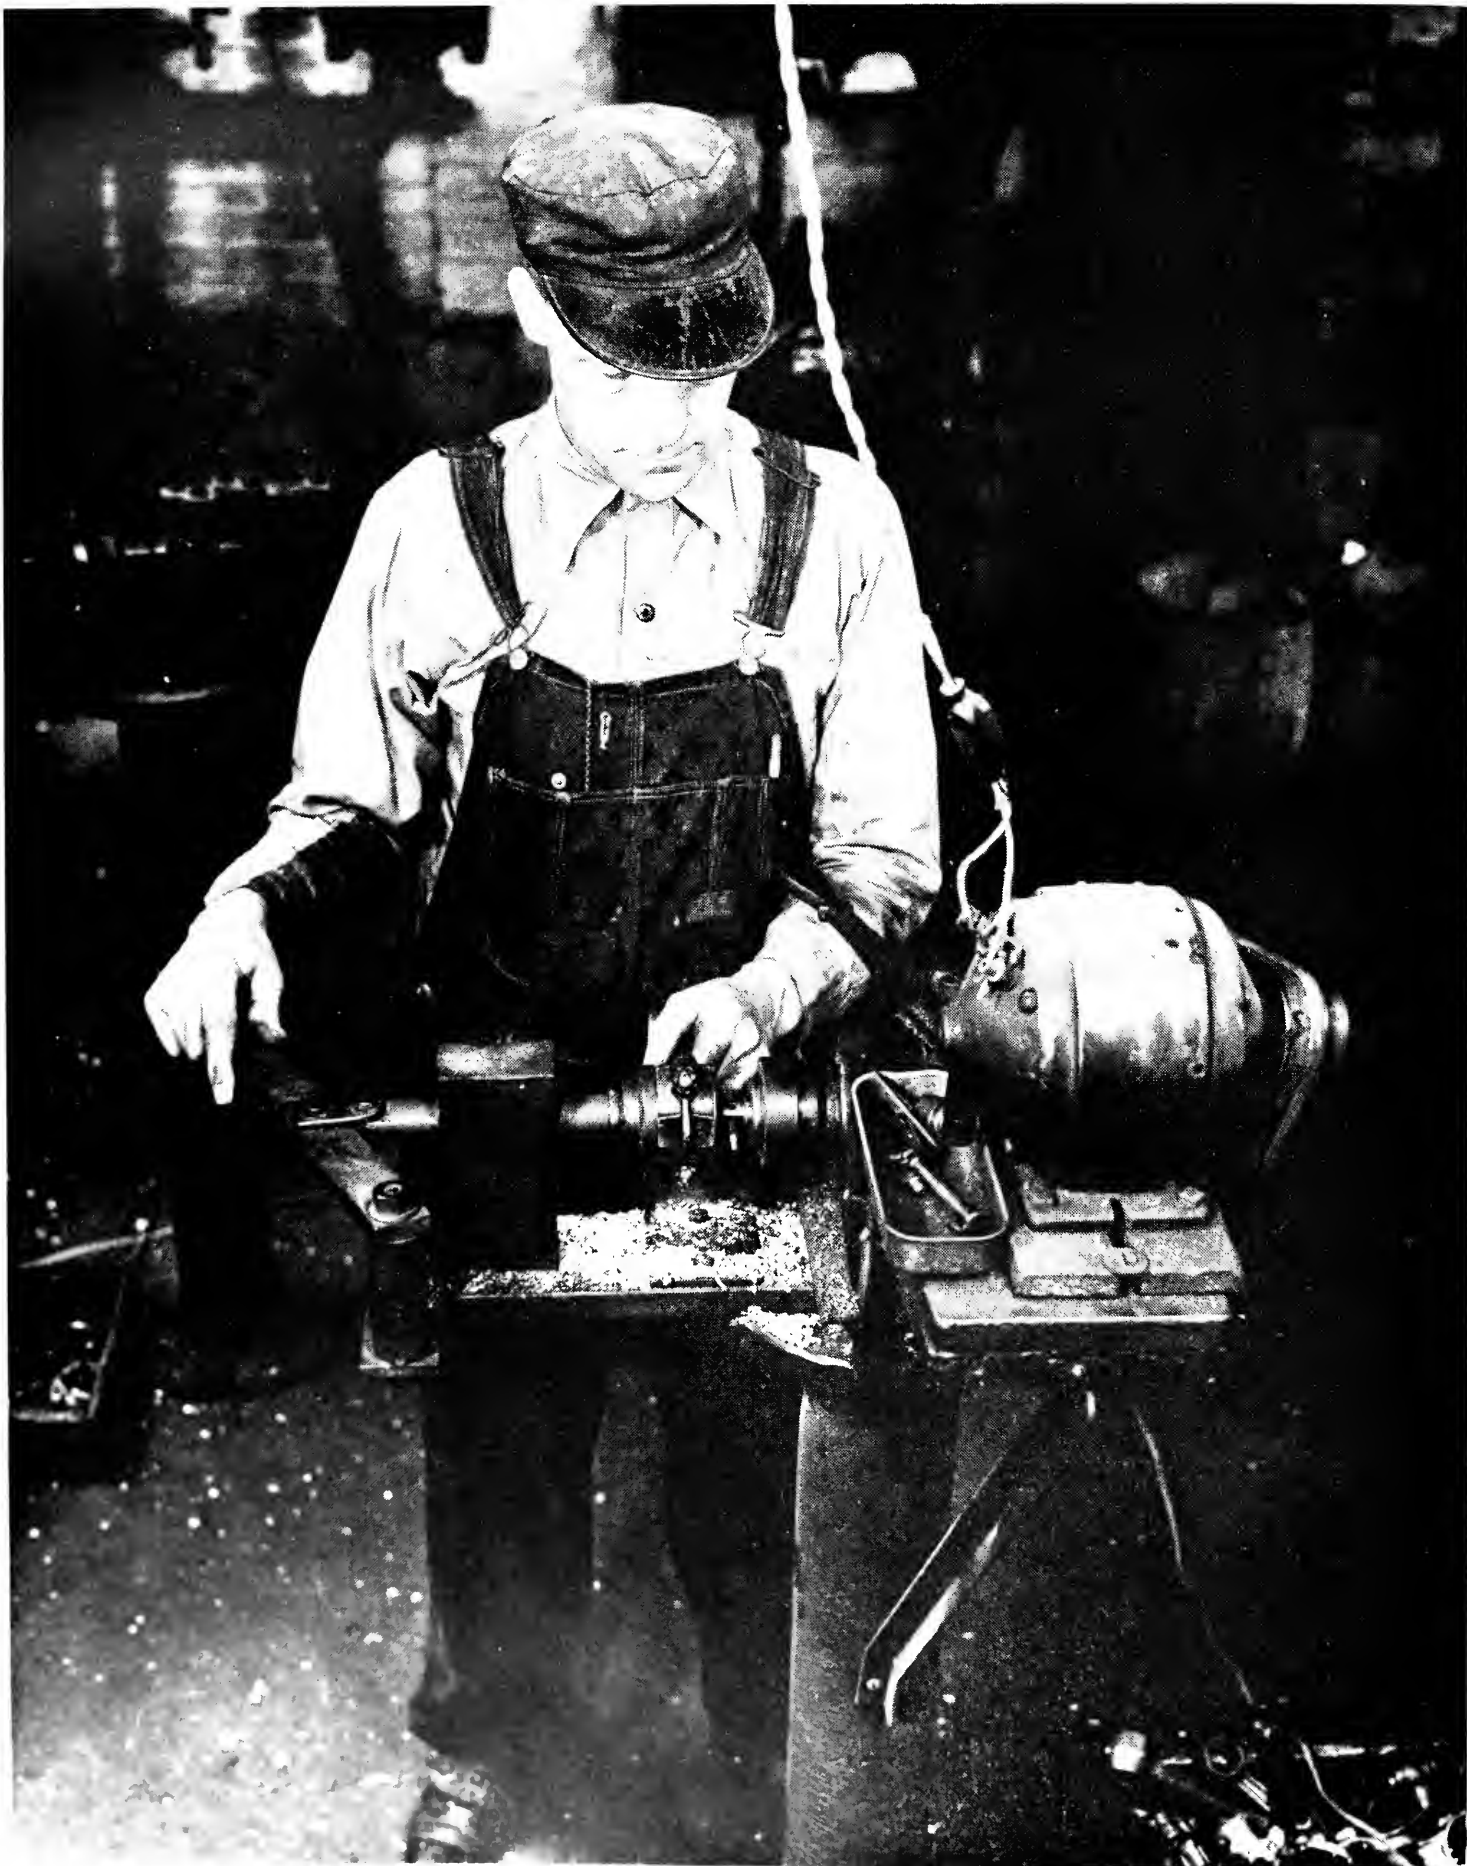
PLAINTIFF'S EXHIBIT No. 29

Certain Pontiac bearings require a continuous oil groove around the center, which is cut by the center oil groover shown in the above picture.

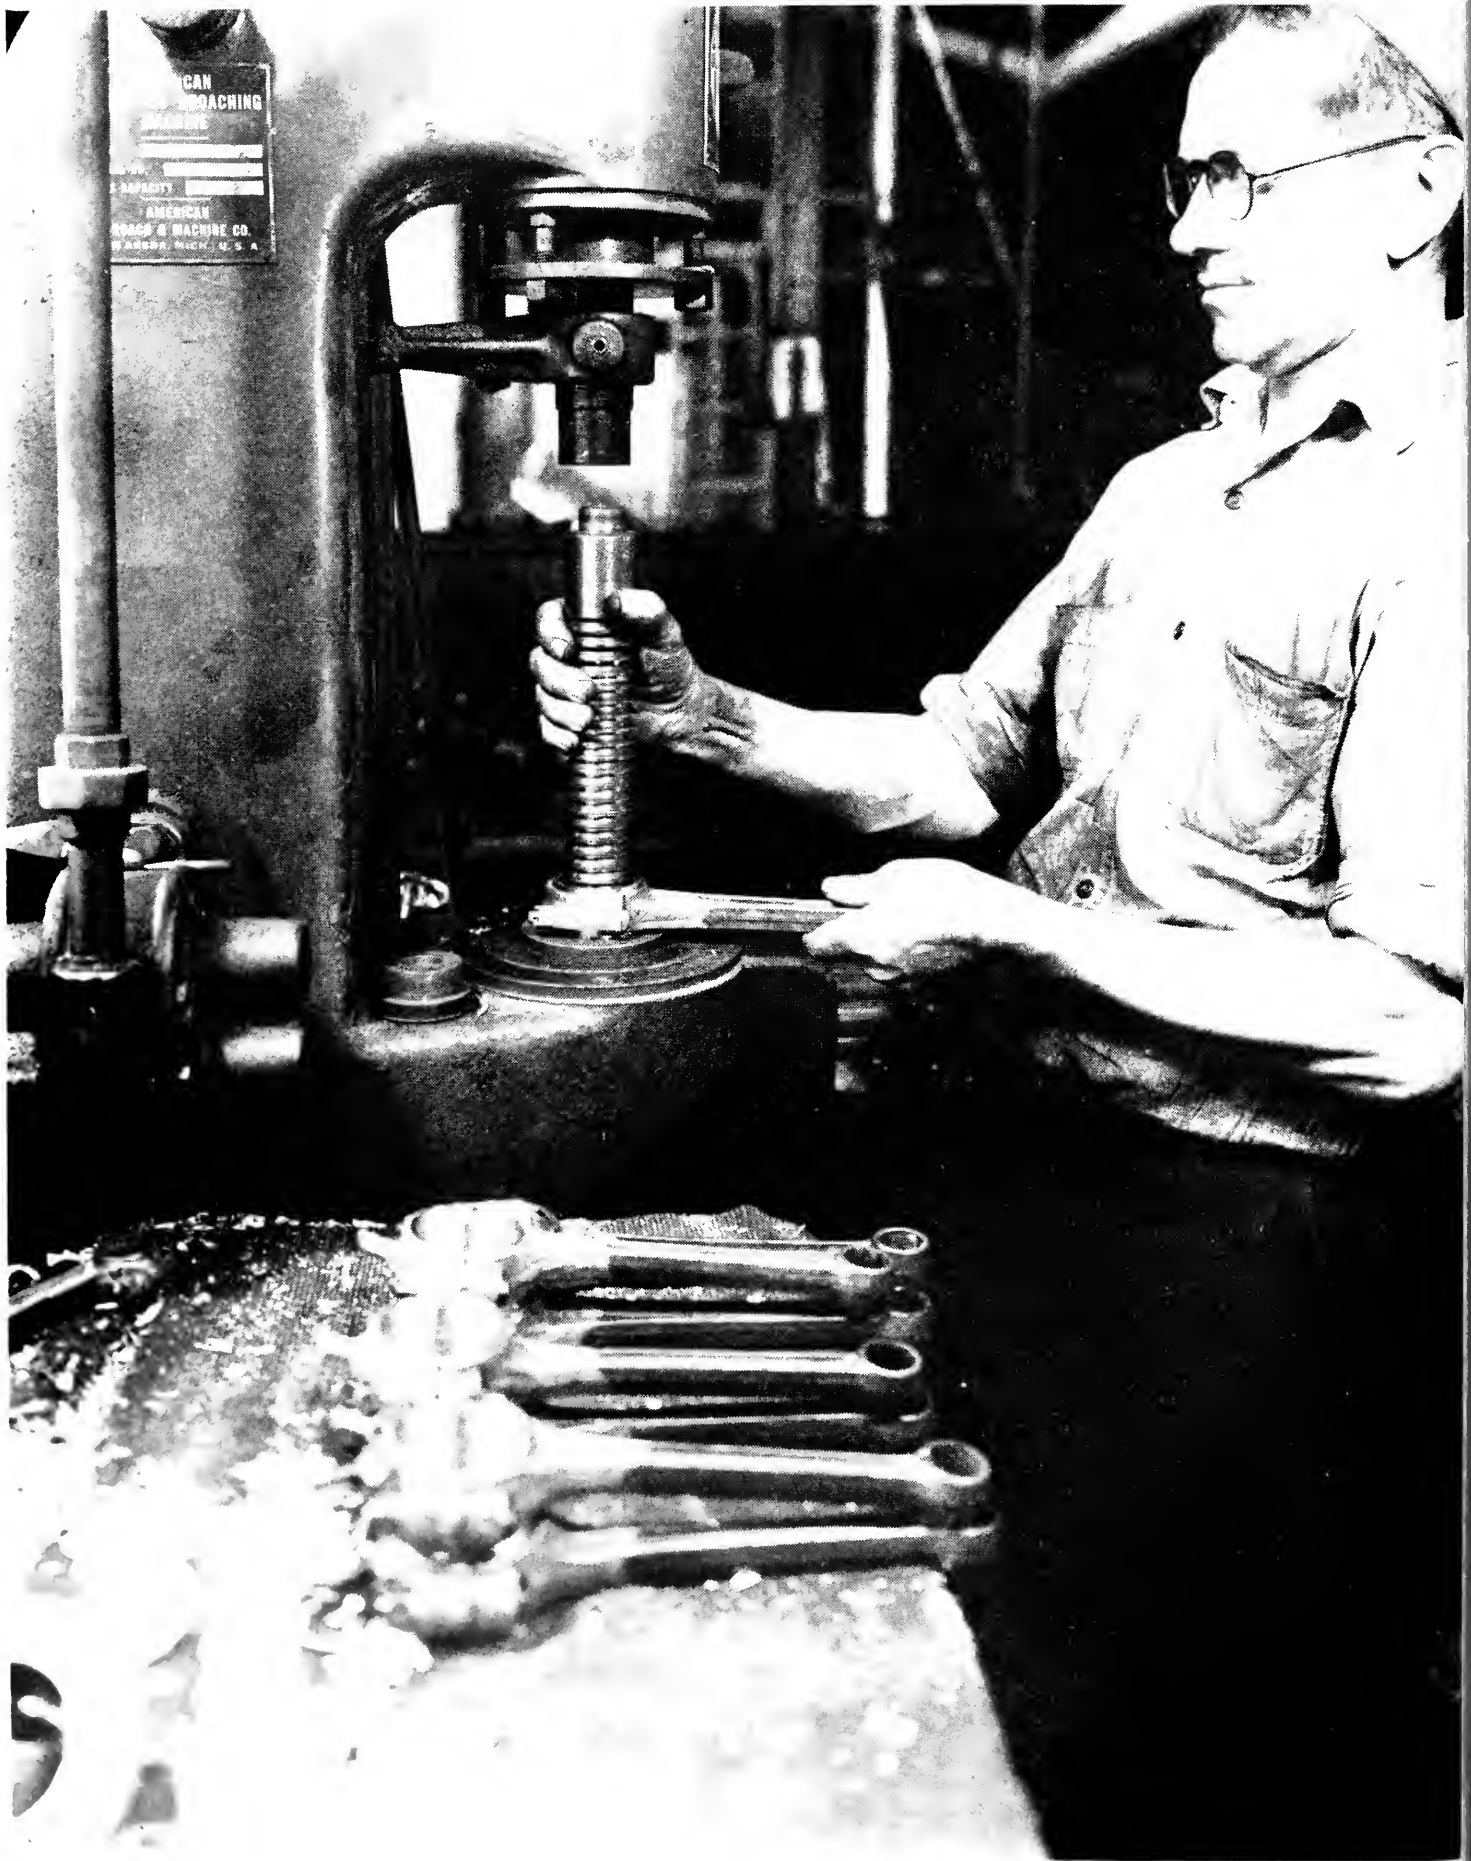
PLAINTIFF'S EXHIBIT No. 30

All babbitt bearings except the twenty per cent which are finished to special undersize on the lathe shown in Picture 22 are now finished to size by a hydraulically operated broaching machine as shown in the above picture. The broaching tool which is used for this operation is held in the workman's right hand. It is composed of a number of horizontal cutters each of which removes about .0005 as the tool is forced through the bearing by the hydraulic pressure.

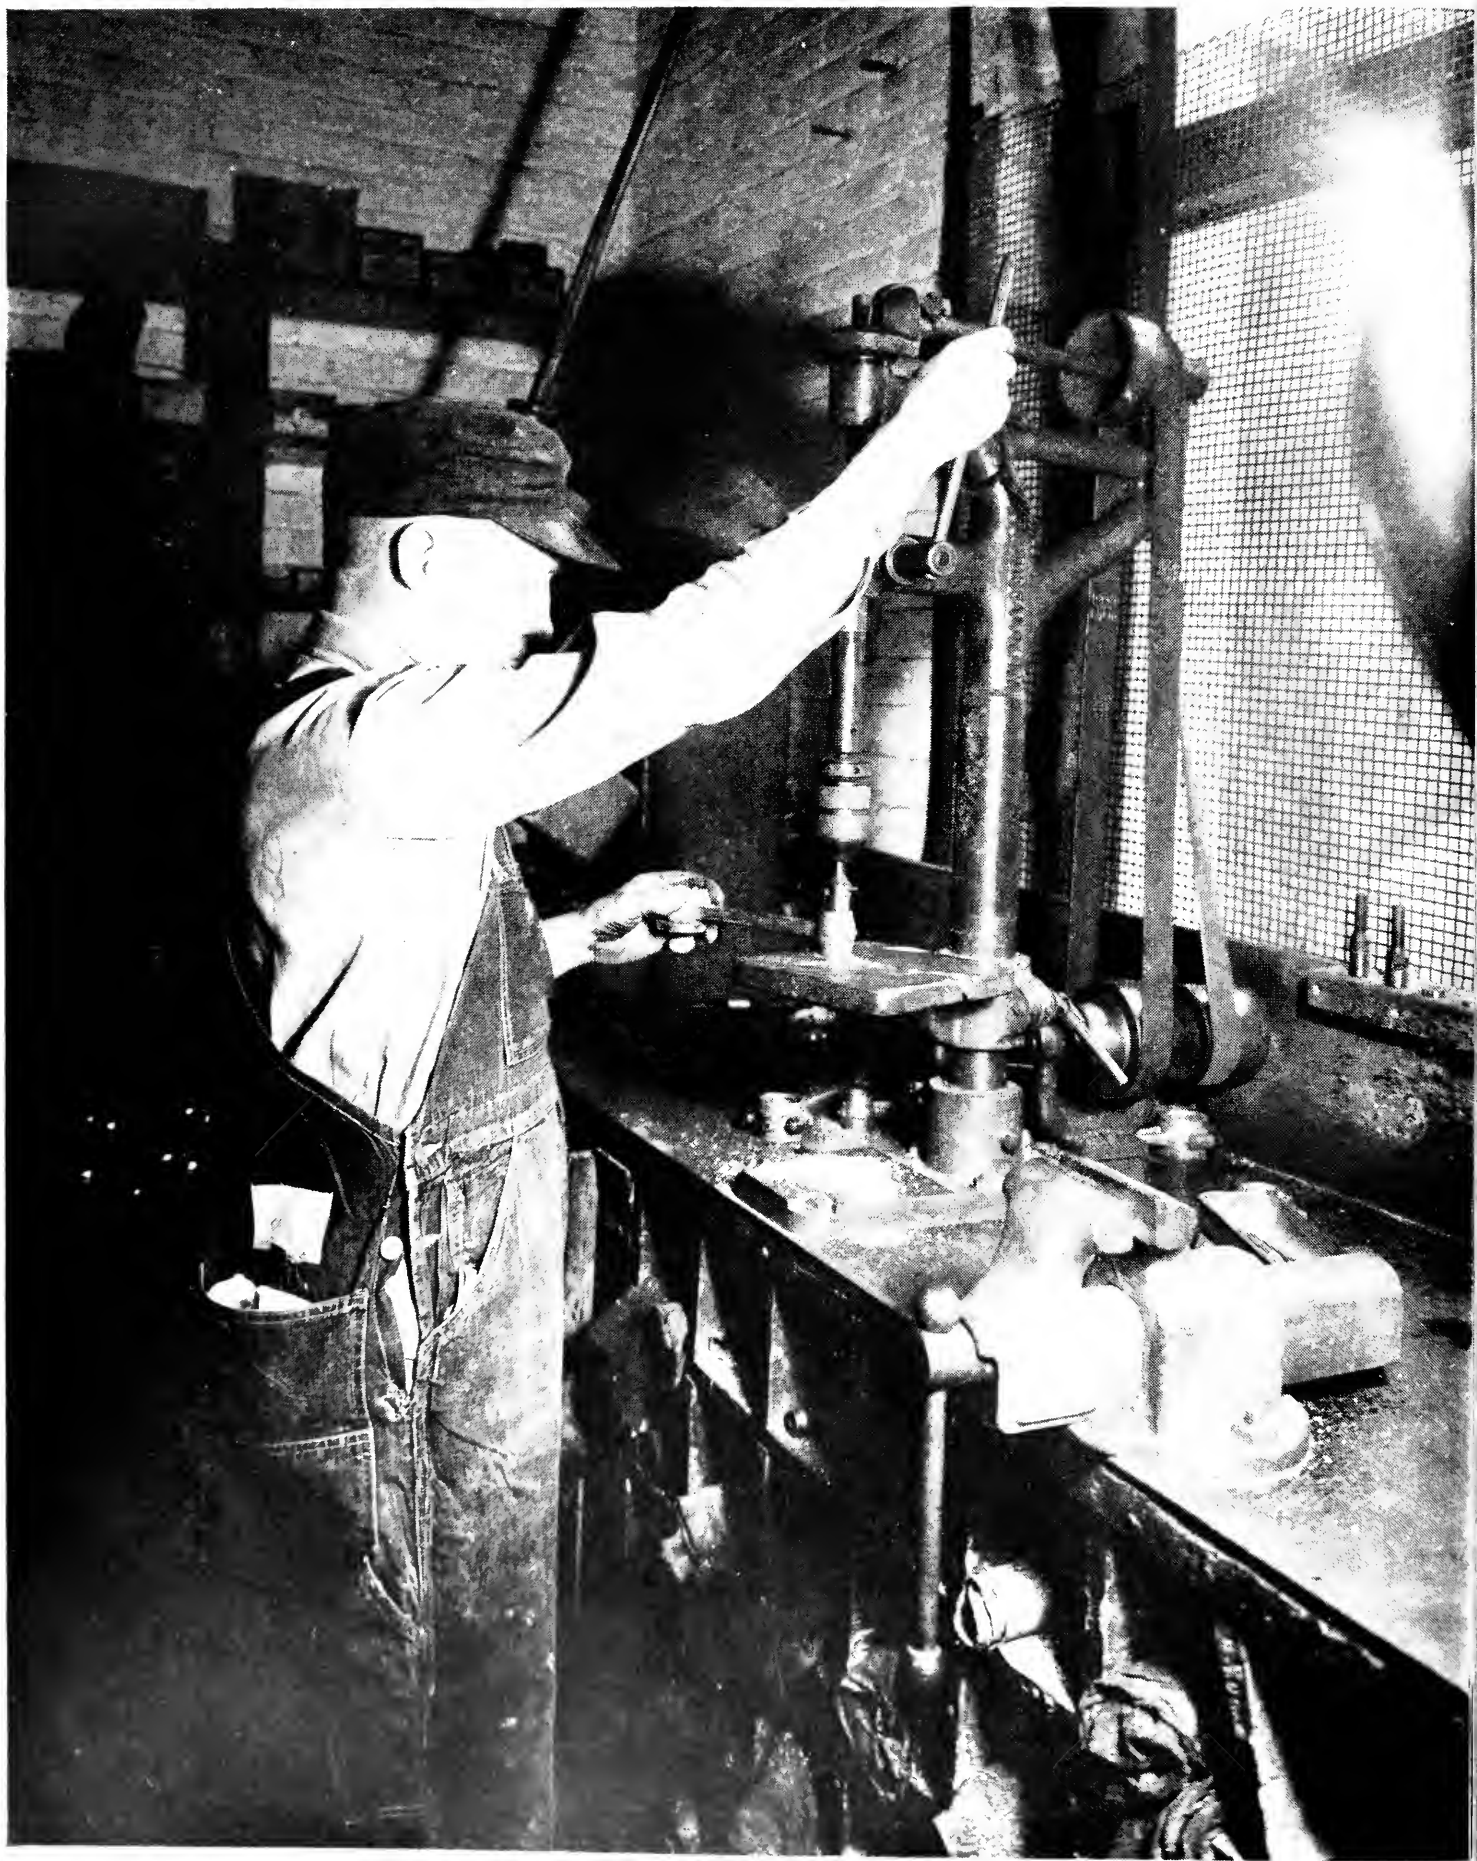
PLAINTIFF'S EXHIBIT No. 31

Model A Ford connecting rods are fitted with a very thin bushing which becomes somewhat damaged and burred when being pressed in by the arbor press shown in Picture 26. This is corrected by placing the connecting rods in a bench drill press in which a chamfering tool is used as shown in the above picture.

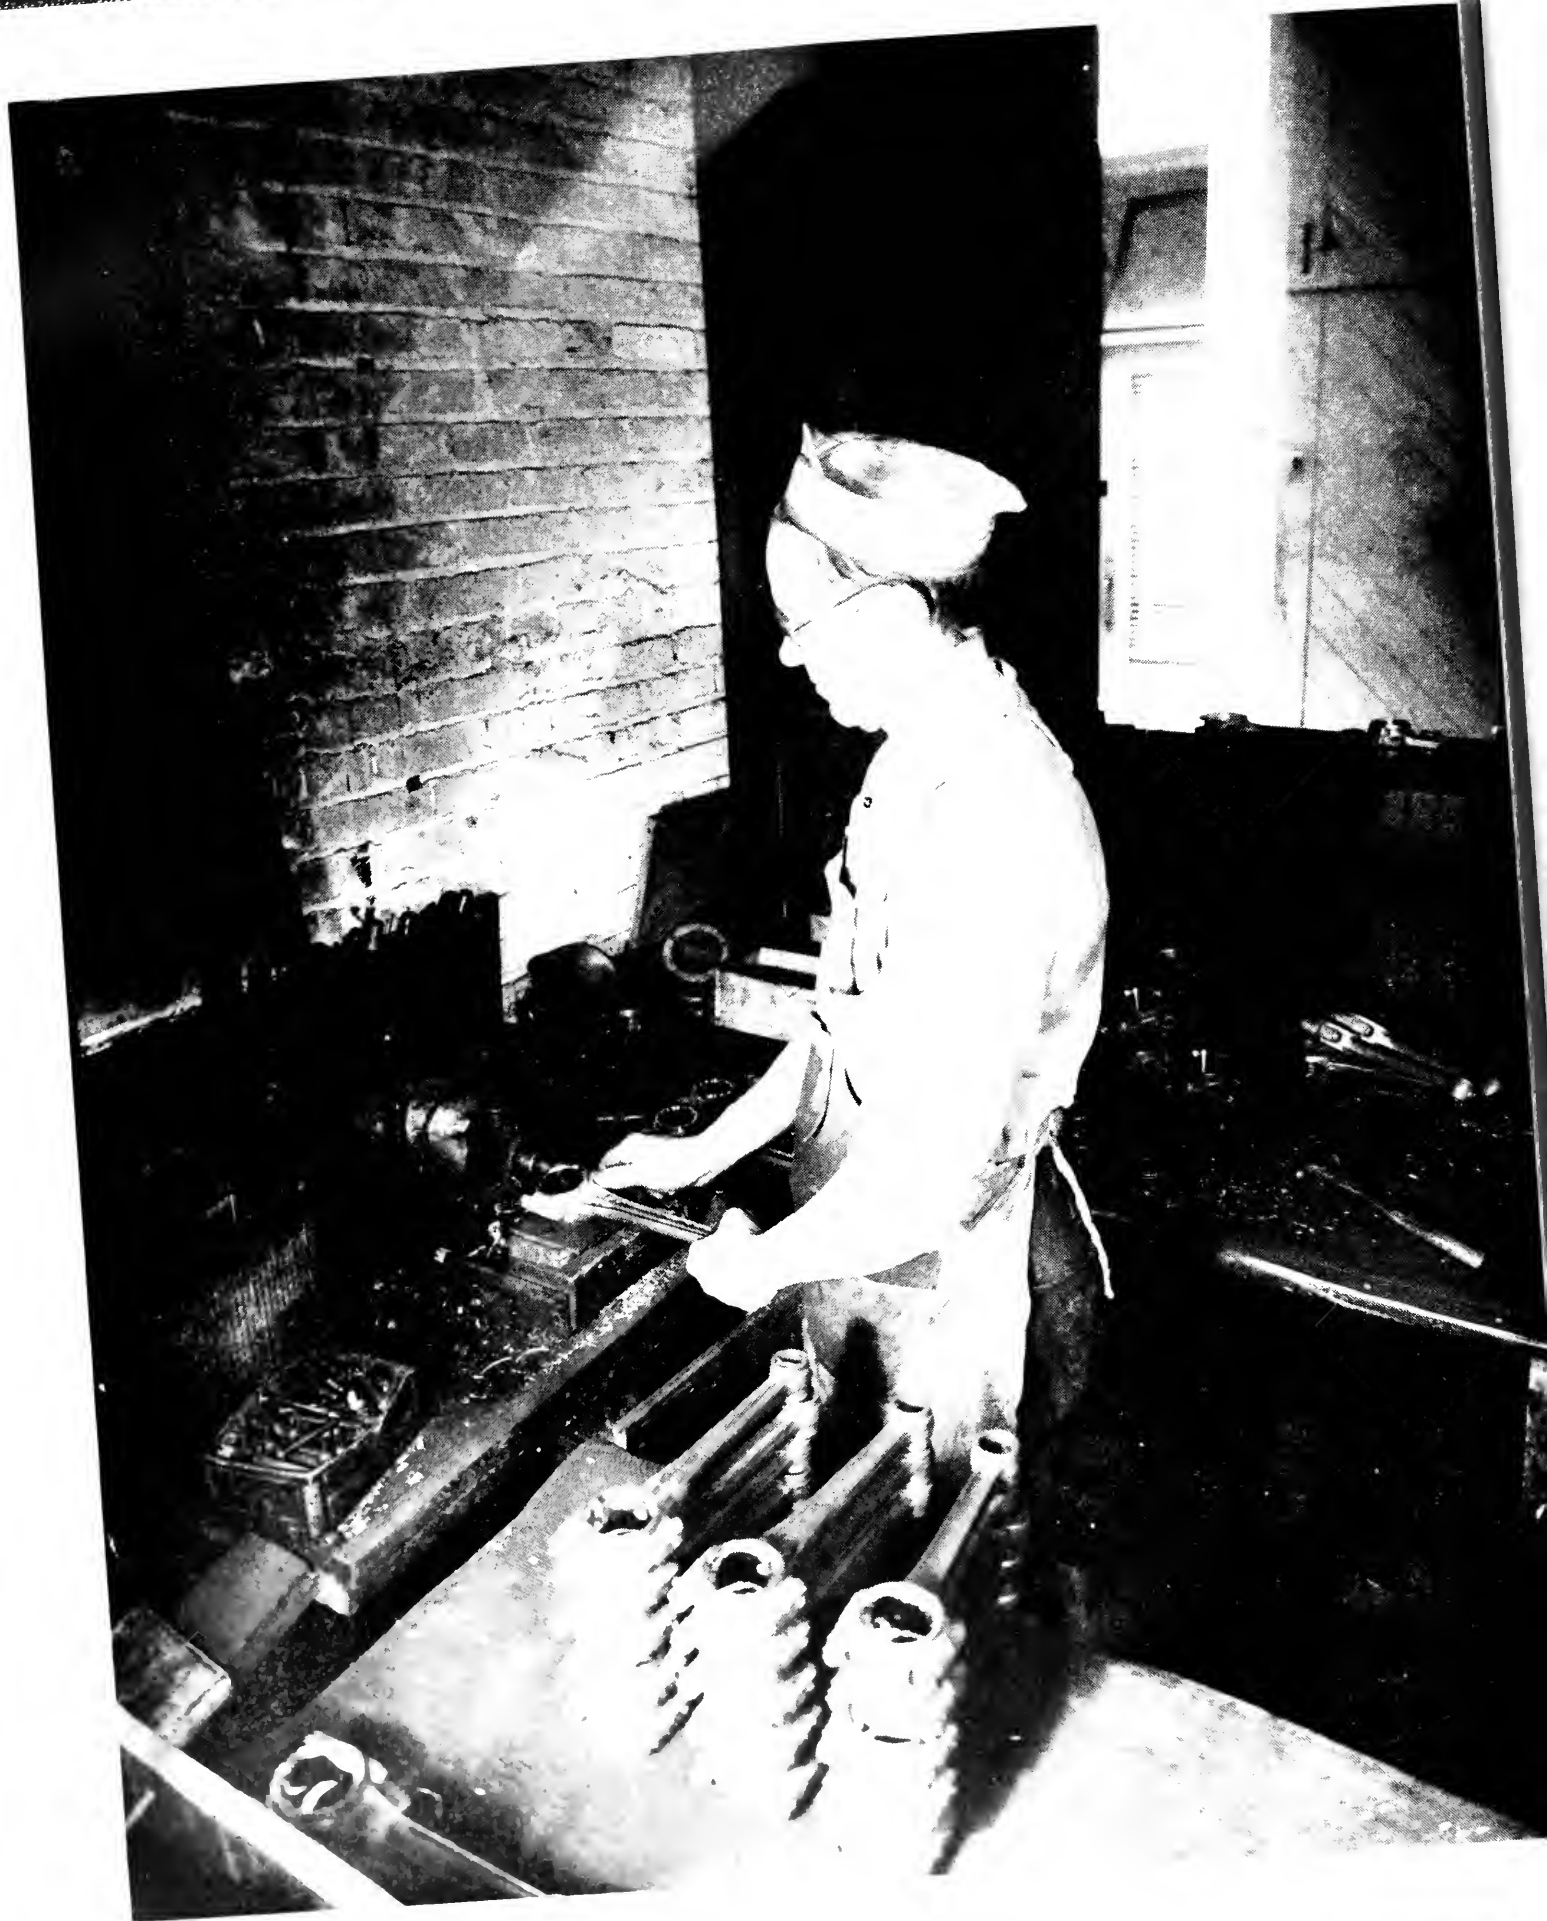
PLAINTIFF'S EXHIBIT No. 32

All connecting rod bearings are now given a final inspection and the nuts holding the connecting rod caps in place are loosened to enable the workman to make certain that the bolt or stud threads have not been stripped. The nuts are loosened by a power operated socket wrench as shown in the above picture.

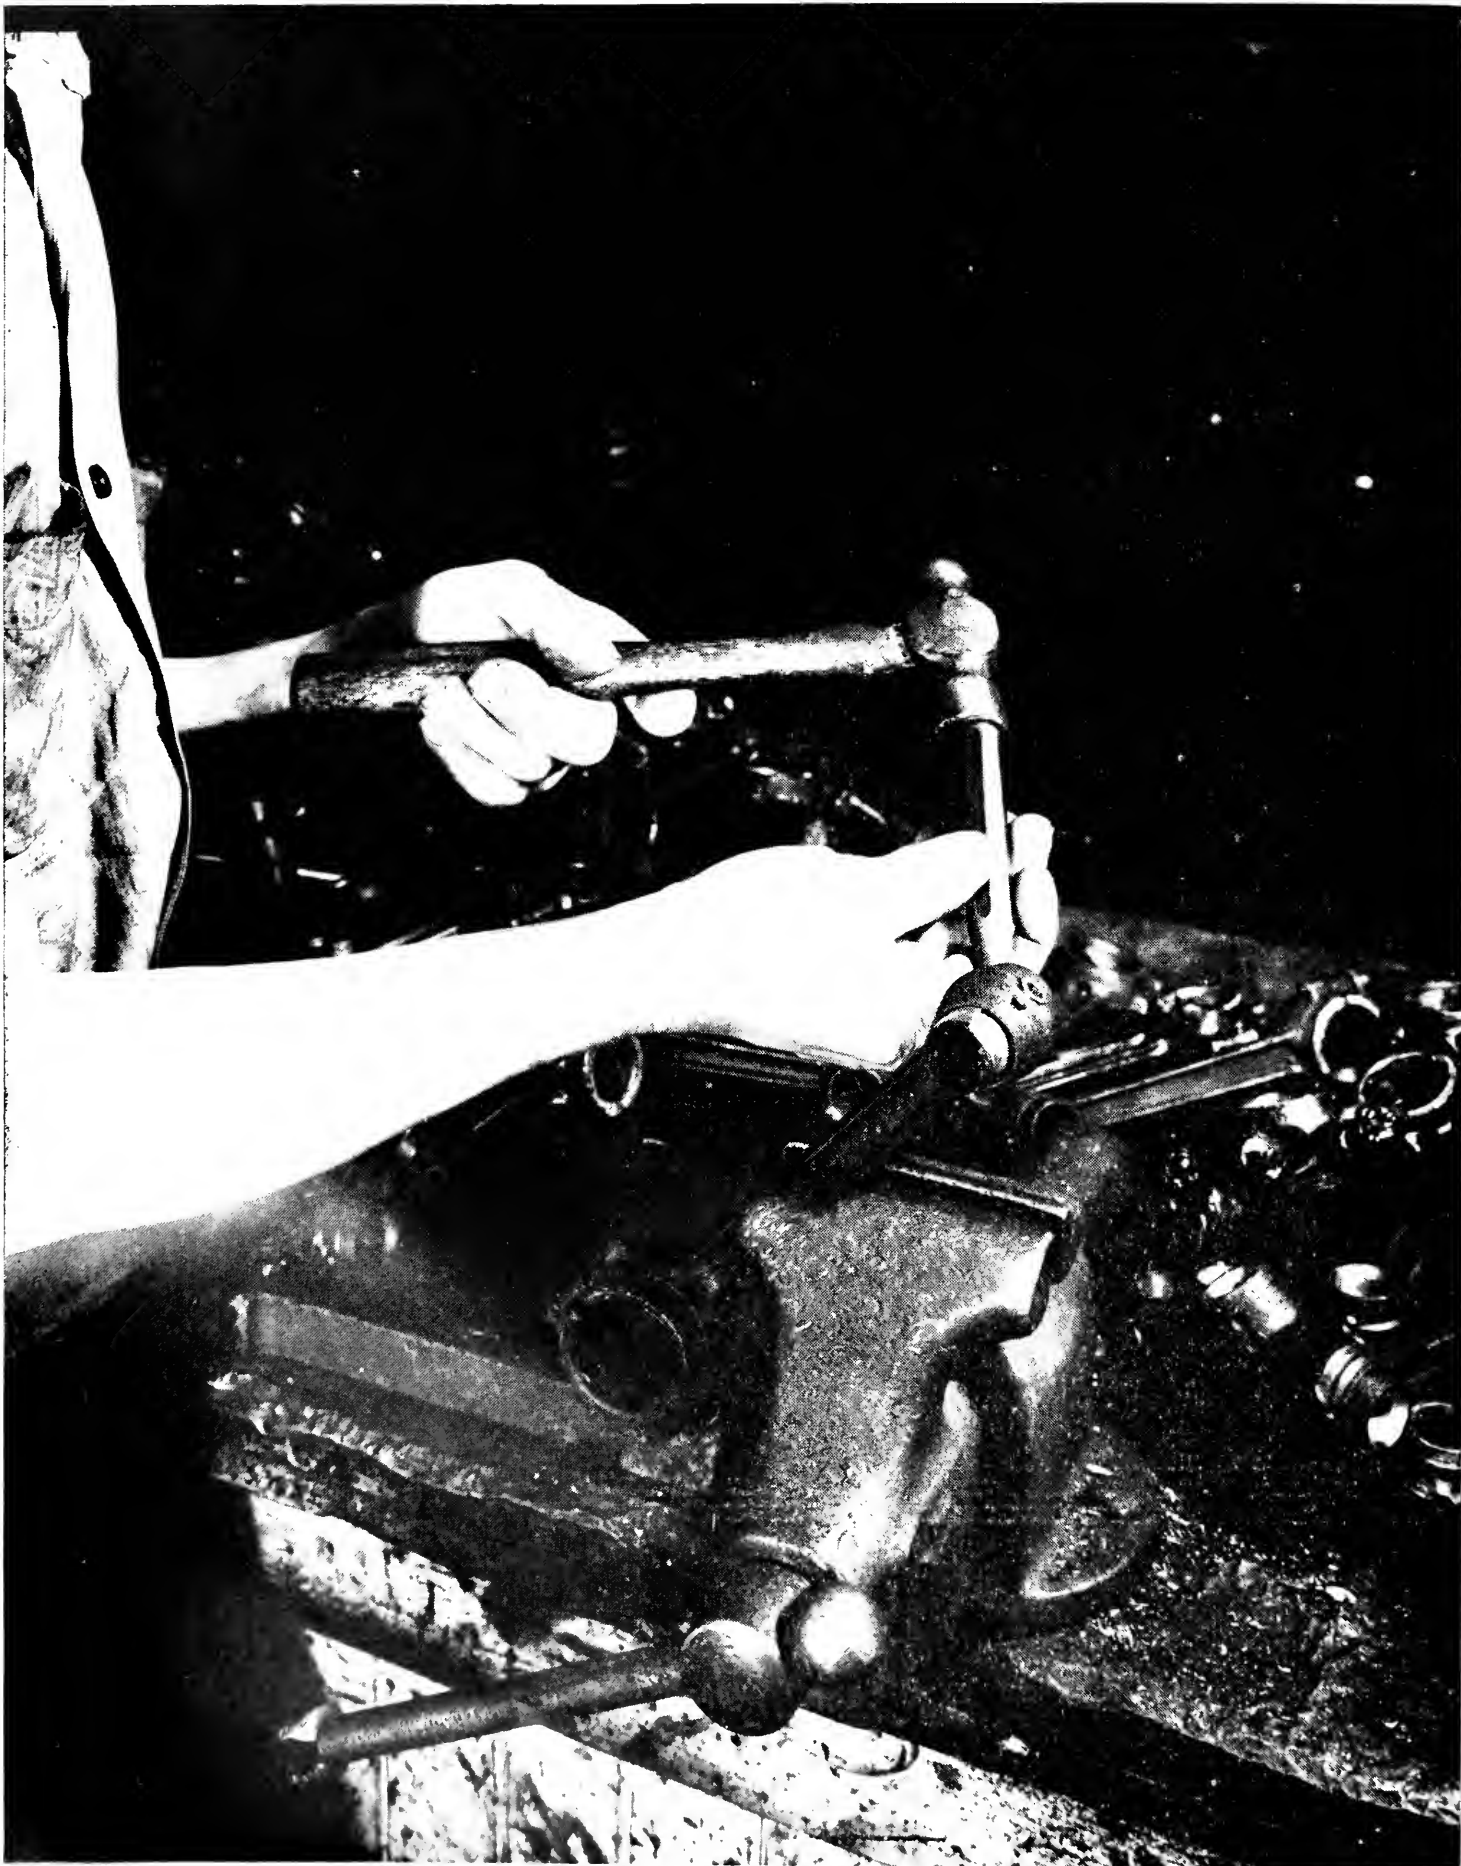
PLAINTIFF'S EXHIBIT No. 3

The rods are then piled on a table in groups according to their respective sizes and the pin bushings are removed. These pin bushings are the bushings at the shank end of the rod. About one half of the rods rebattitted by Plaintiff corporation use pin bushings. The other half are of a clamp type shank end and using no such pin bushings this operation of removal is not necessary. And sometimes the instructions received read "Do not change bushings." These pin bushings are of two types: Those with a thin wall which cannot be pressed out and which must be therefore pounded out by means of a cold chisel and hammer as shown above while

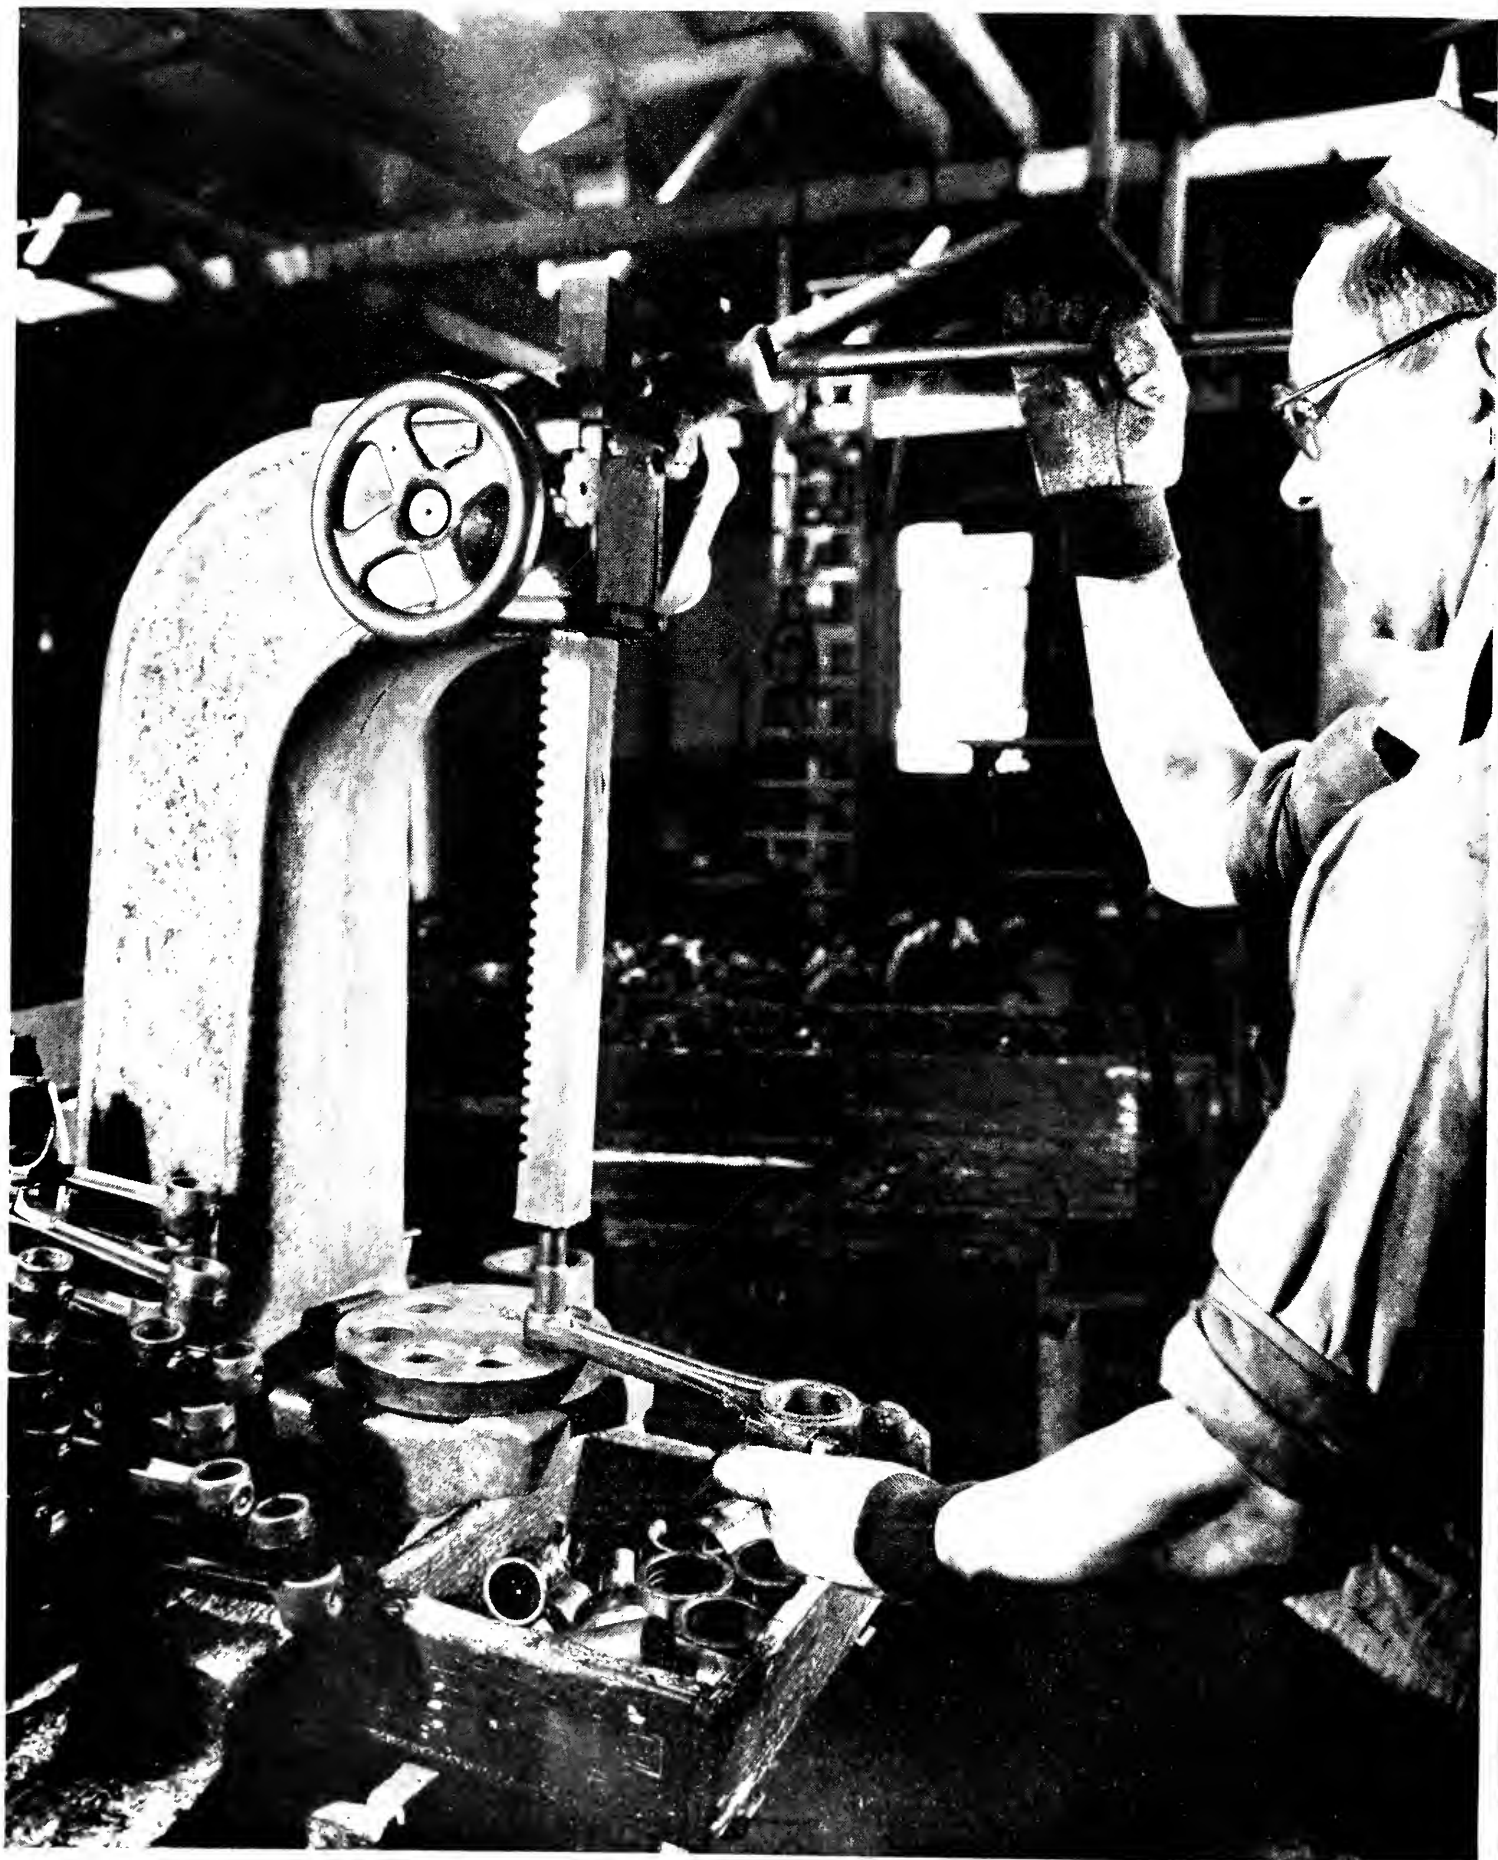
PLAINTIFF'S EXHIBIT No. 4

Other pin bushings have a heavy wall and are removed by use of an ordinary arbor press as shown above. It is much simpler and faster to remove the bushings in this manner.

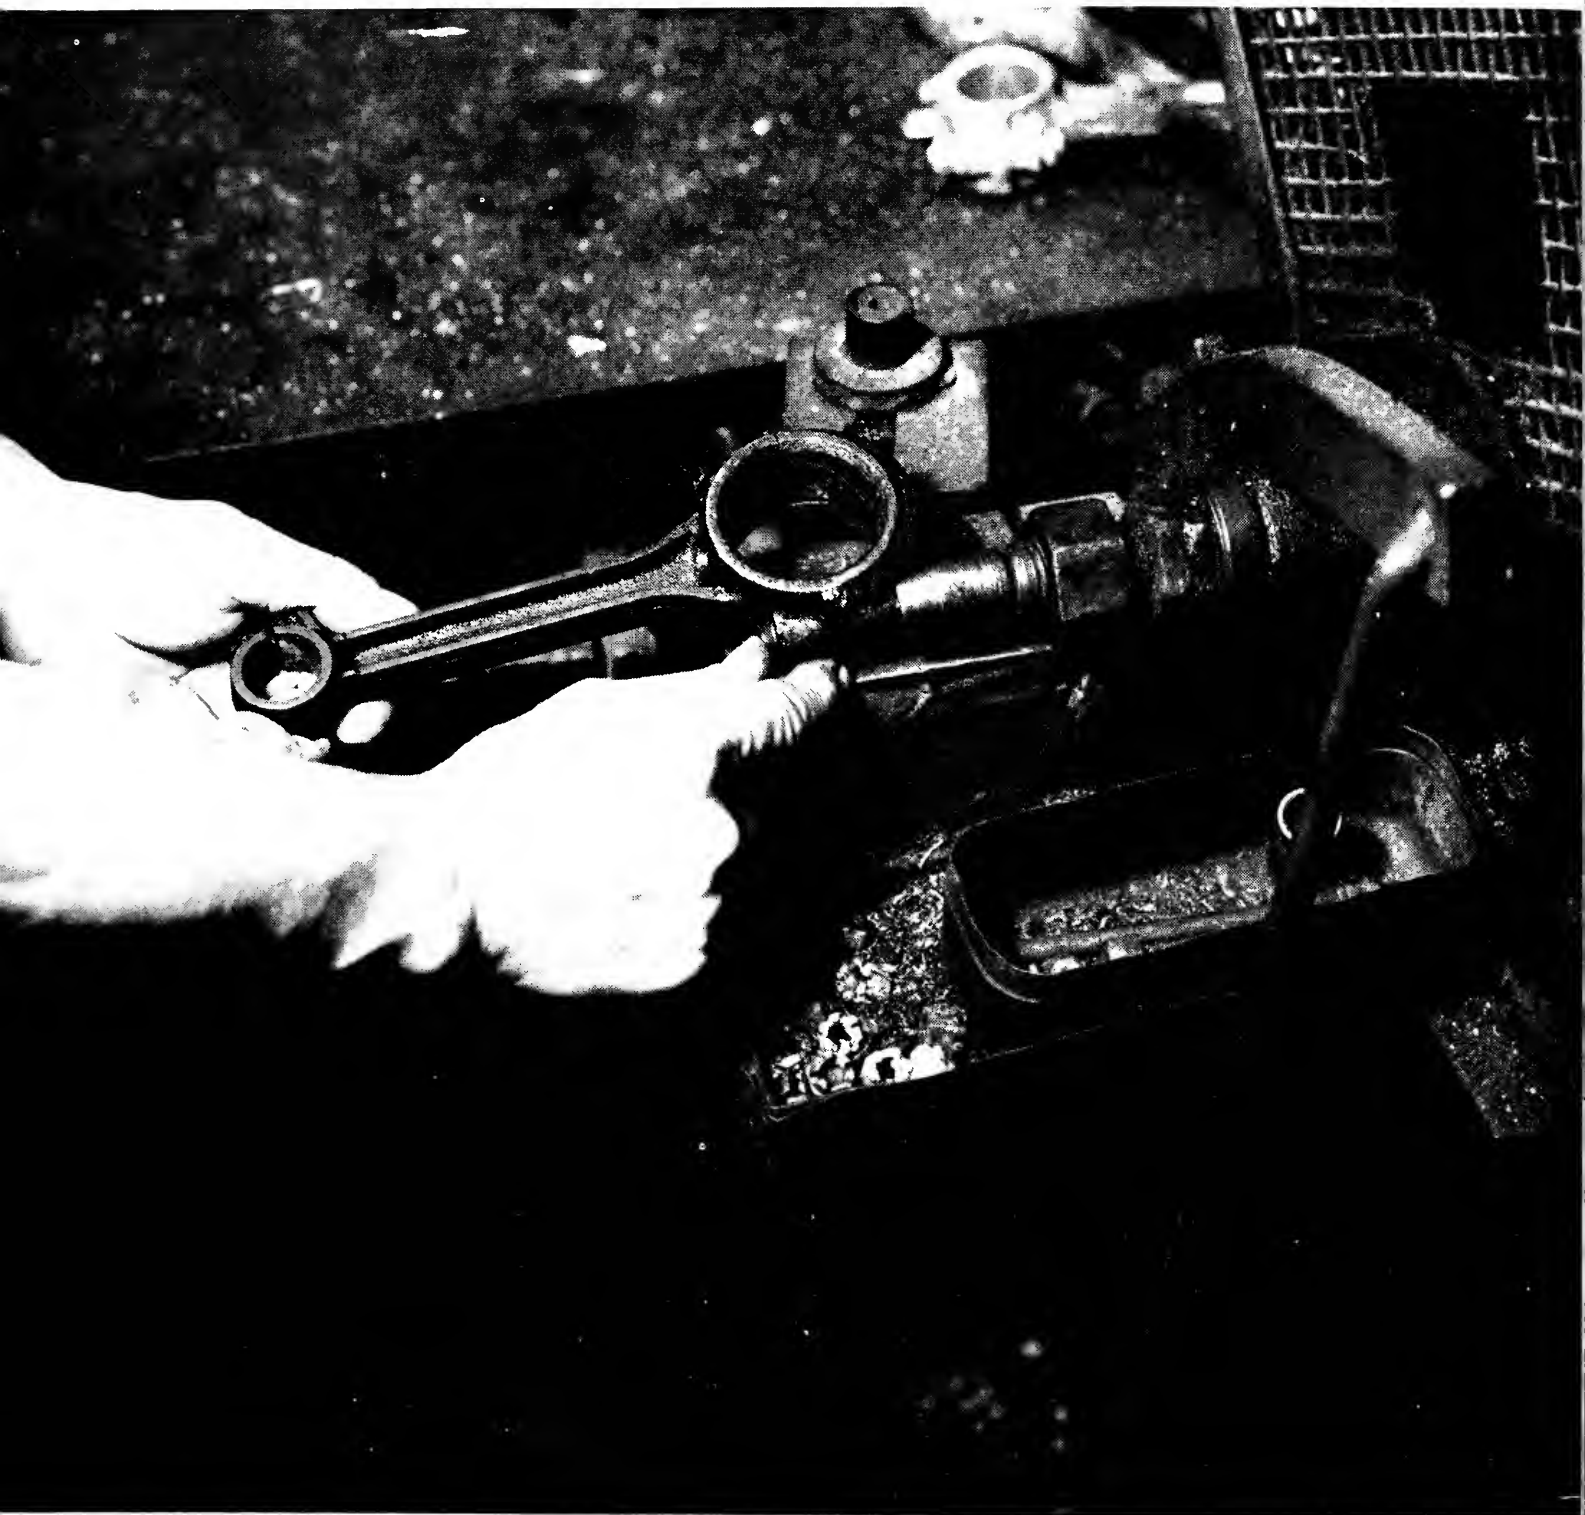
PLAINTIFF'S EXHIBIT No. 5

On about one half of the rods it is necessary to remove the bolts and nuts which fasten the cap to the shank and replace these bolts and nuts with auxiliary bolts and nuts which have already been dipped in solder. The nuts and bolts so removed are placed in a box and later replaced on the rods in place of the auxiliary nuts and bolts when the rebabbiting process is completed. The same cap always goes back on the same shank otherwise in the centrifugal casting the babbitt will leak. However, on Ford products the bolts are not removed for the reason that no bolts are made, but rather, a stud has been forged with the shank and cannot be removed. However, the nuts are similarly changed and for the same reason as in the case of the other rods. The reason for this operation is that on about one half of the types of rods the nuts and bolts have never been immersed in solder, and it is desired to rebabbitt the rod so that its appearance resembles that of its original condition as nearly as possible. On the other one half of the rods, that is on the rods on which the nuts and bolts have previously to the time received by Plaintiff corporation been immersed in solder, there is no necessity for this operation, and the nuts and bolts are merely tightened if they are loose. The tightening of the nuts and bolts is accomplished by means of an ordinary hand socket wrench attached to a slowly revolving power driven spindle operated by means of a foot lever as shown above. The opposite end of this spindle revolves in the opposite direction and is used in loosening and removing the nuts and bolts, by the same type socket.
